THE CARDON MANAGEMENT GROUP
1841 EASTON AVENUE, BETHLEHEM, PA 18017

July 1, 2004

SUBJECT: Boom Hoist - Motor Vessel Leon I

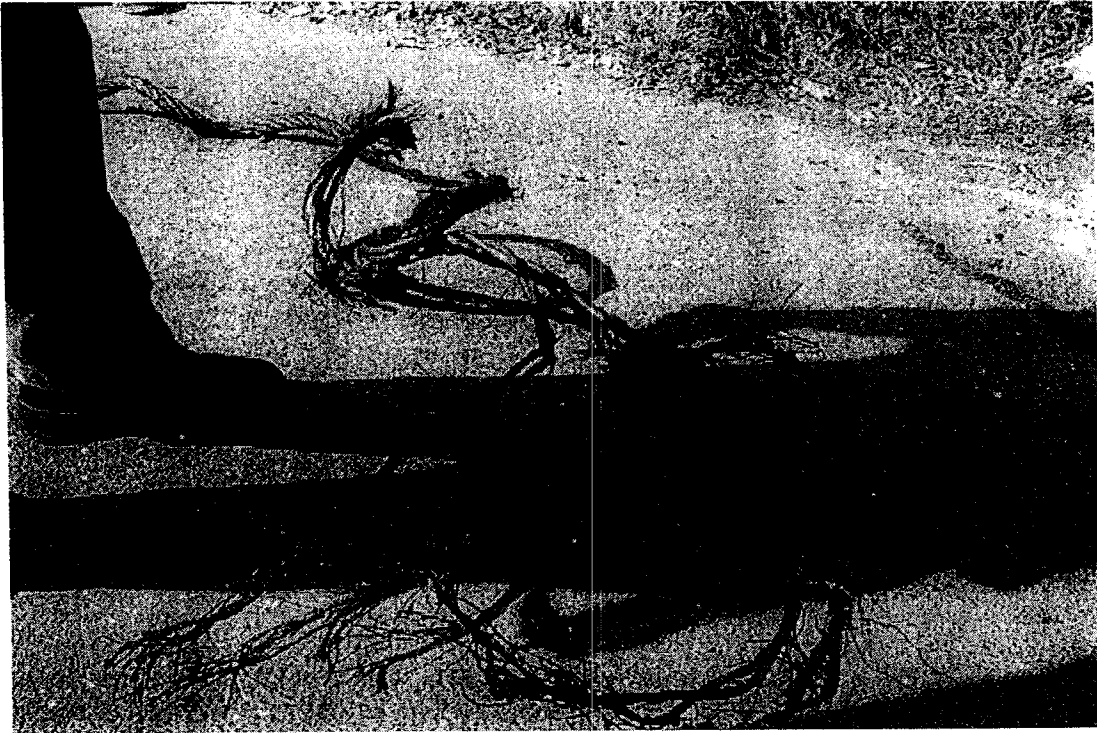
Photograph Marked DSC00285

This photograph illustrates the post-accident condition of one end of the broken wire rope at the point of failure, displaying the severe corkscrew-like distortion of the wire rope. The appearance of this kind of extreme mechanical damage is ample demonstration that the wire rope was trapped and forced to bend while under tension over a very small radius at this point.

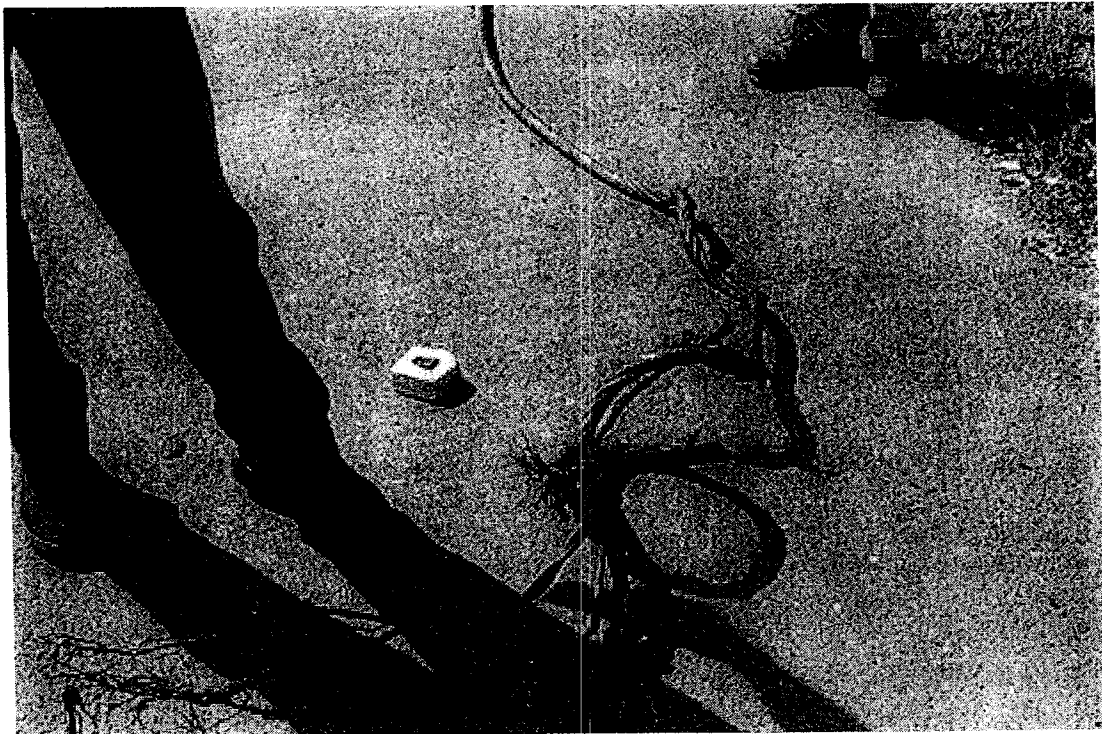
Photograph Marked DSC00289

This photograph illustrates the post-accident condition of the other end of the broken wire rope at the point of failure illustrating that one strand failed first under tension in the region of severe mechanical distortion leading to sequential and immediate failure of the other strands at points where there is no similar distortion illustrative of small radius bending.

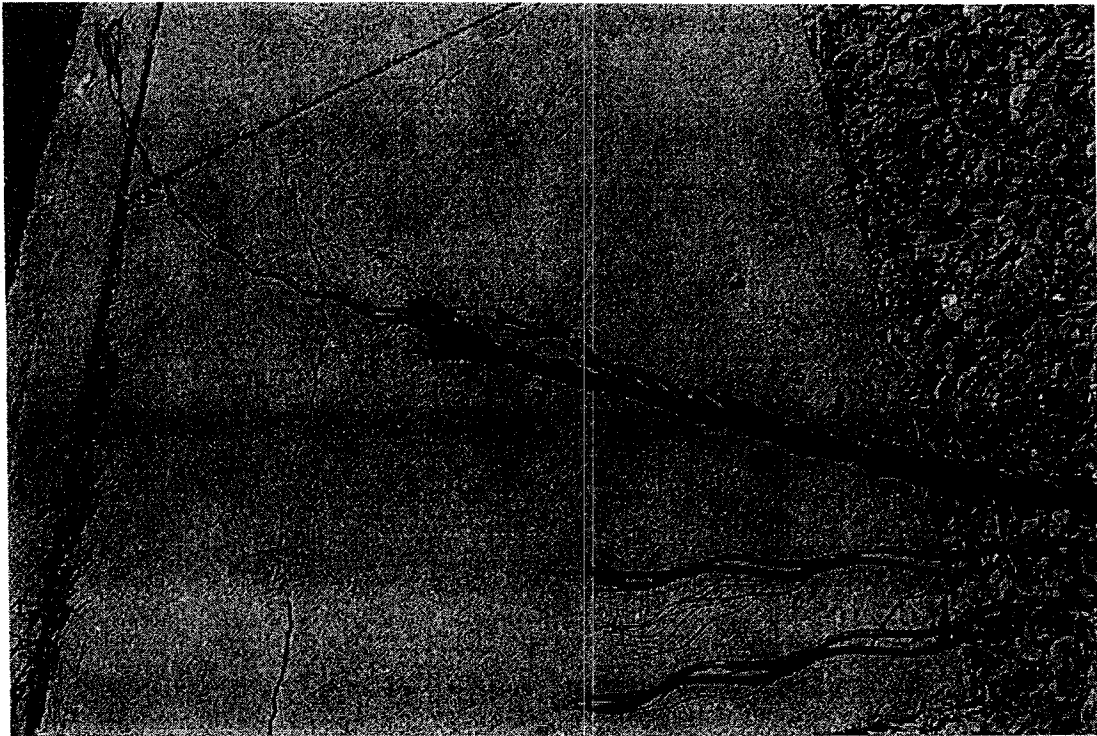
Photograph Marked DSC00286

This photograph of the wire rope in post-accident condition at the point of failure shows the location, evidenced by the taped cut ends, which appears to be the place where a sample length was removed during an earlier investigation. It is obvious there is no severe mechanical deformation caused by small radius bending in the region immediately adjacent to the point of failure.
